# II. An in-situ harmful algal bloom monitoring system in Oklahoma lakes

5/7/13 Oklahoma Water Survey - Integrating in-situ field measurements and satellite remote sensing to monitor harmful algae blooms in Oklahoma lakes

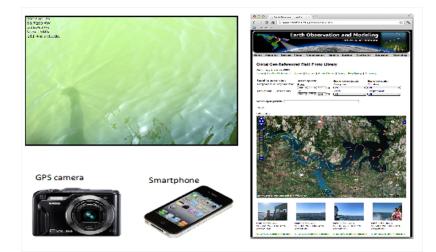
Figure 3. An introduction on the Global Geo-Referenced Field Photo Library. (a) a geo-referenced field photo, and (b) GPS camera and smartphone, and (c) a screenshot of the Field Photo Library at the EOMF website (http://www.eomf.ou.edu/photos).

The Earth Observation and Modeling Facility (EOMF) at the University of Oklahoma has developed the Global Geo-Referenced Field Photo Library, which is a citizen-science tool for people to share, visualize, and archive geo-referenced field photos around the globe (Xiao et al. 2011). Figure 3 shows an example of geo-referenced field photos available for Lake Texoma, which were collected during a field trip on June 5, 2012. These field photos can be used for

qualitative assessment of water quality by water professionals and educated citizens; and they can also be used for quantitative assessment of water quality by remote sensing professionals. The field photos in the Field Photo Library are linked with satellite images (e.g., time series MODIS data

from 2000 to present). Users can upload, edit, query, and download field photos in the library, and use the thematic databases associated with the field photos for various geospatial analyses. III.5. A web-based tool for visual assessment of freshwater harmful algal blooms
